**DOCUMENTATION OF PLACES  
FOR ENTRY IN THE  
REGISTER OF HERITAGE PLACES**

1. **DATA BASE No.** *P06358*
2. **NAME** *Stone dwelling (ruin), Howatharra  
Chinaman House –stone ruin*
3. **LOCATION** adjacent Oakajee River, Howatharra
4. **DESCRIPTION OF PLACE INCLUDED IN THIS ENTRY**  
(leave for Land Information Officer to fill in )
5. **LOCAL GOVERNMENT AREA** Shire of Chapman Valley
6. **OWNER** (leave for Land Information Officer to fill in )
7. **HERITAGE LISTINGS**
  - Register of Heritage Places: \_\_\_\_\_
  - National Trust Classification: \_\_\_\_\_
  - Town Planning Scheme: \_\_\_\_\_
  - Municipal Inventory: Adopted 31/10/1996
  - Register of the National Estate: \_\_\_\_\_
8. **CONSERVATION ORDER**  
\_\_\_\_\_
9. **HERITAGE AGREEMENT**  
\_\_\_\_\_
10. **STATEMENT OF SIGNIFICANCE**

*Stone dwelling (ruin), Howatharra*, the remains of a purpose built vernacular stone dwelling, has cultural heritage significance for the following reason:

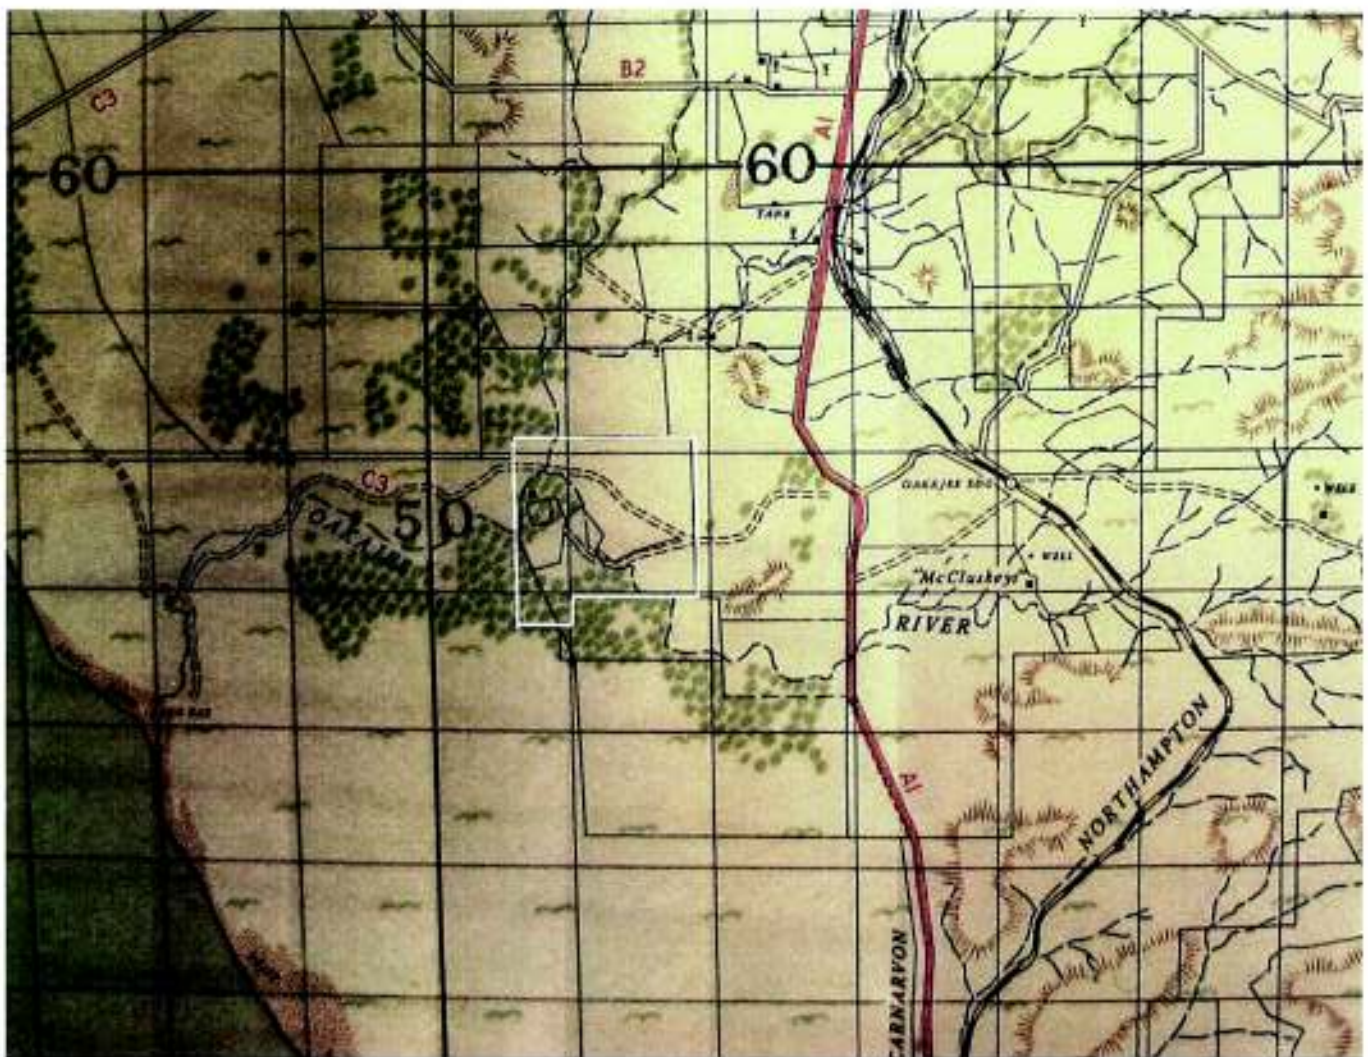
1943 map showing a building on Location 5663 in the location of the Stone Hut. Royal Australian Survey Corp (Army), CN15, 37/4 (433C), Northampton.

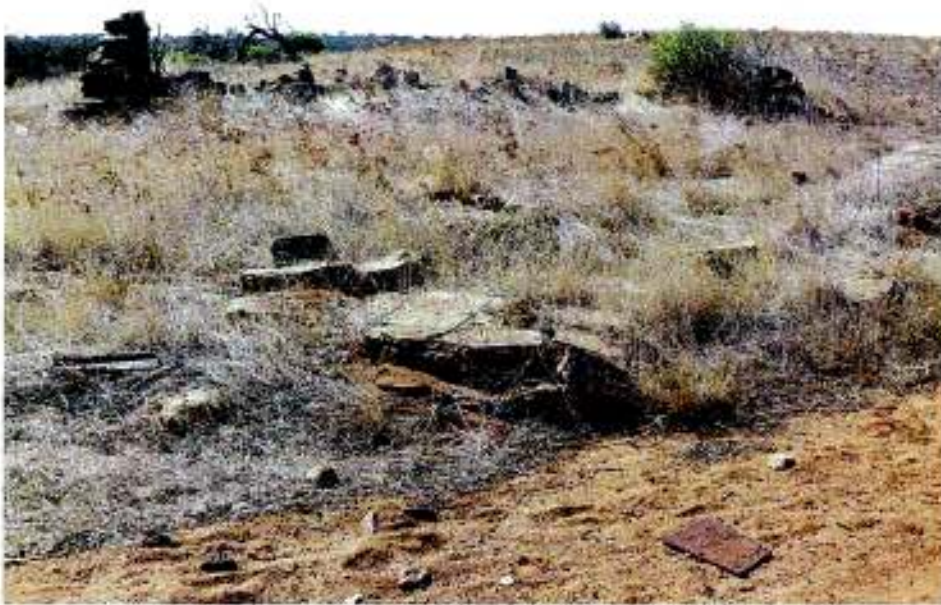
*P06358 Stone dwelling (ruin), Howatharra* View looking east showing remnant wall at north end (left) and stone remains from there to the small bush (right). L Gray 15 April 2010.

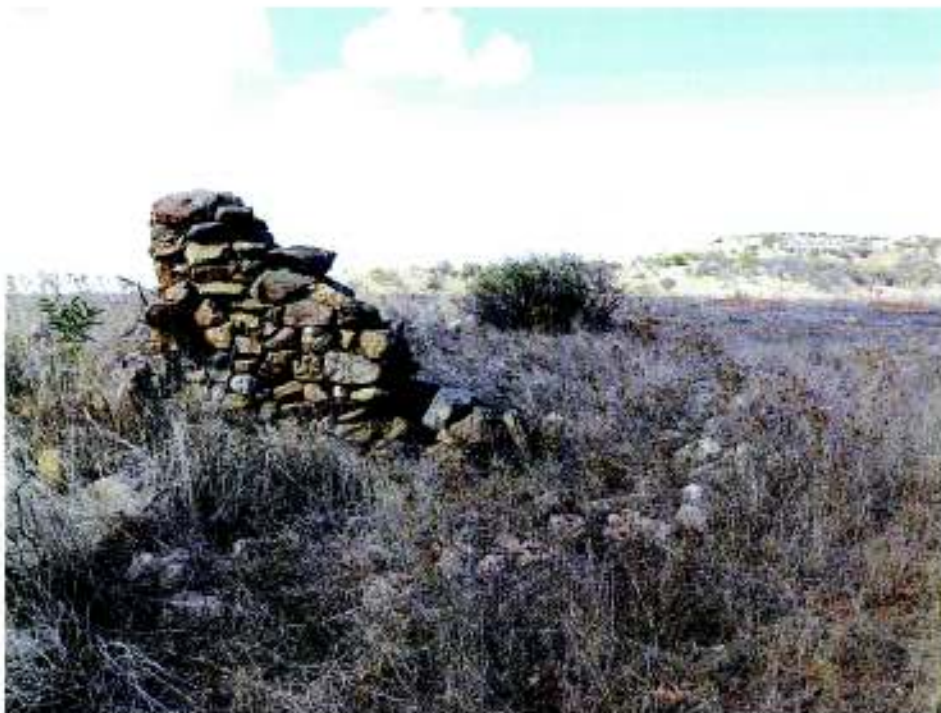
*P06358 Stone dwelling (ruin), Howatharra* View looking south showing remnant wall at north end. L Gray 15 April 2010.

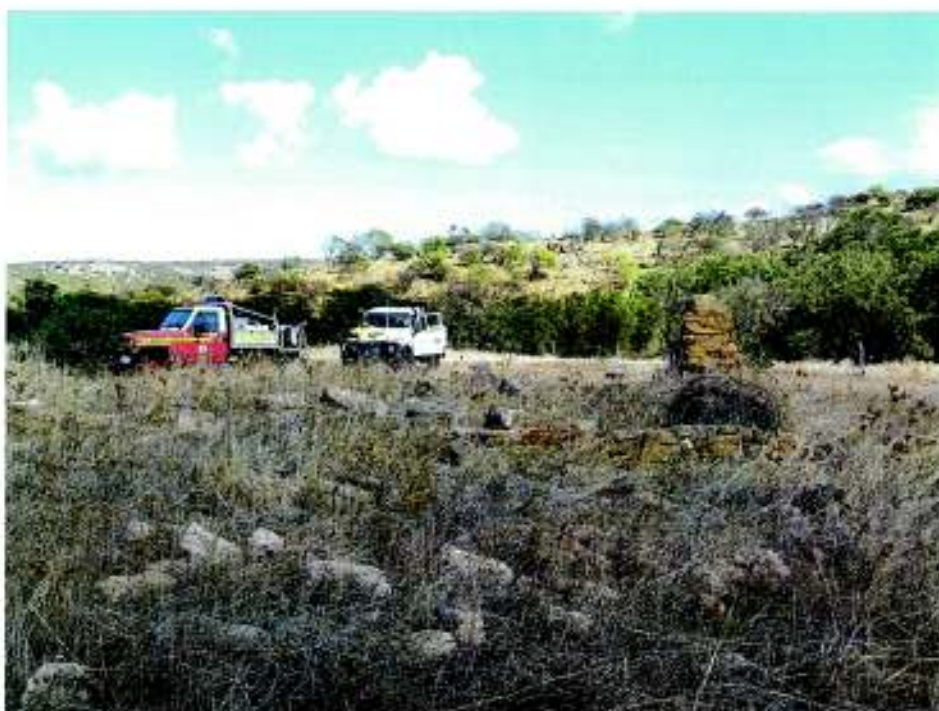
*P06358 Stone dwelling (ruin), Howatharra* View looking west showing Oakajee River evidenced by the trees. Also showing remnants of the eastern wall and strewn stone elements. L Gray 15 April 2010.

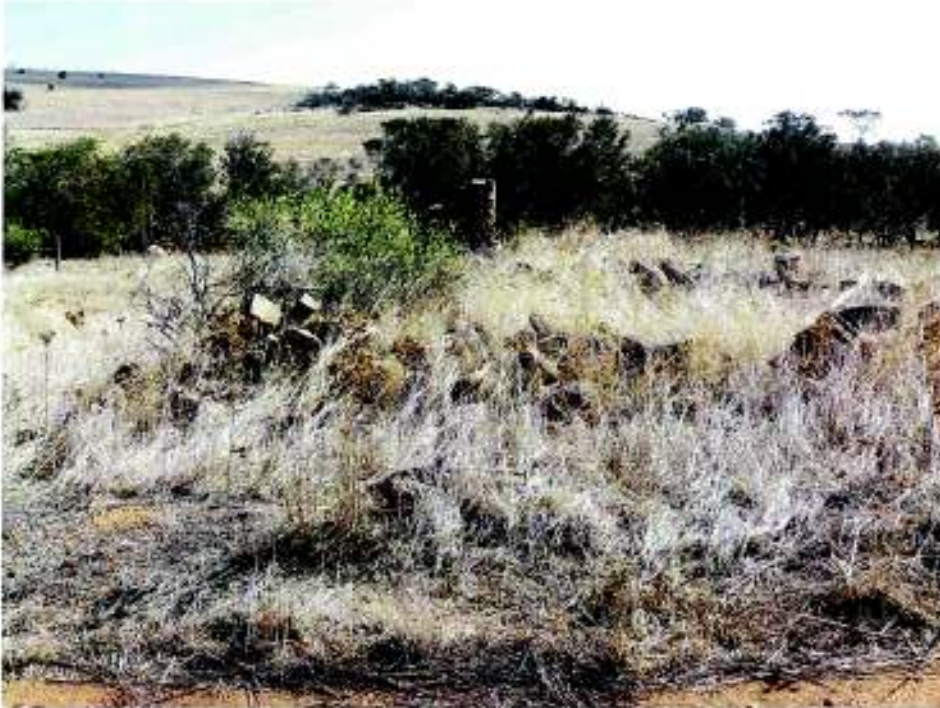
*P06358 Stone dwelling (ruin), Howatharra* View looking northwest showing Oakajee River evidenced by the trees, and remnants of the southern wall and strewn stone elements. L Gray 15 April 2010.

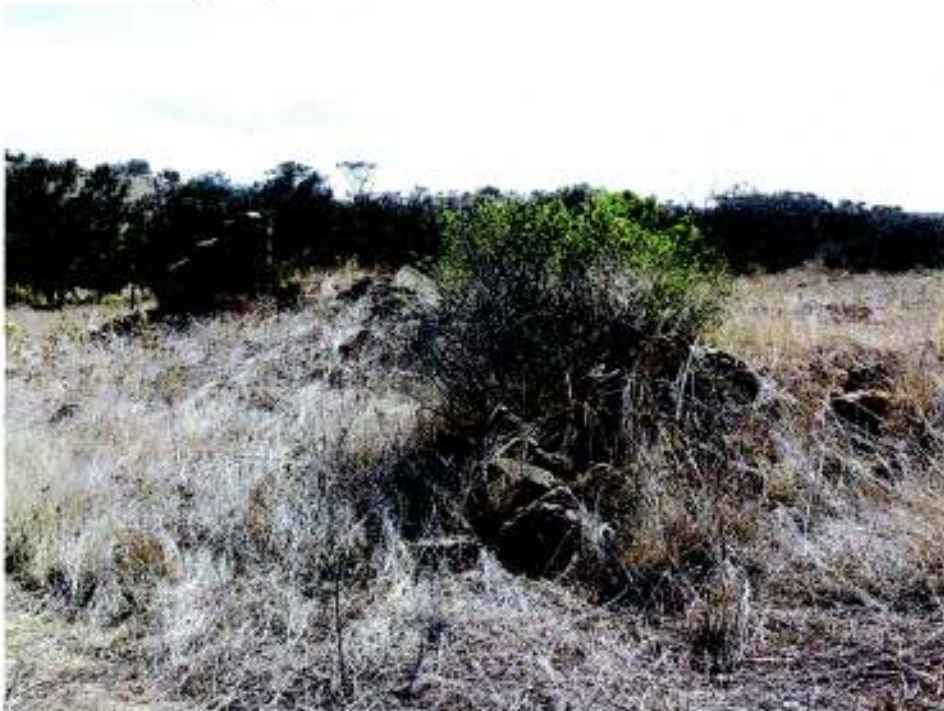
*P06358 Stone dwelling (ruin), Howatharra* View looking northeast showing north wall remains (left) and remnants of the southern wall (right). L Gray 15 April 2010.

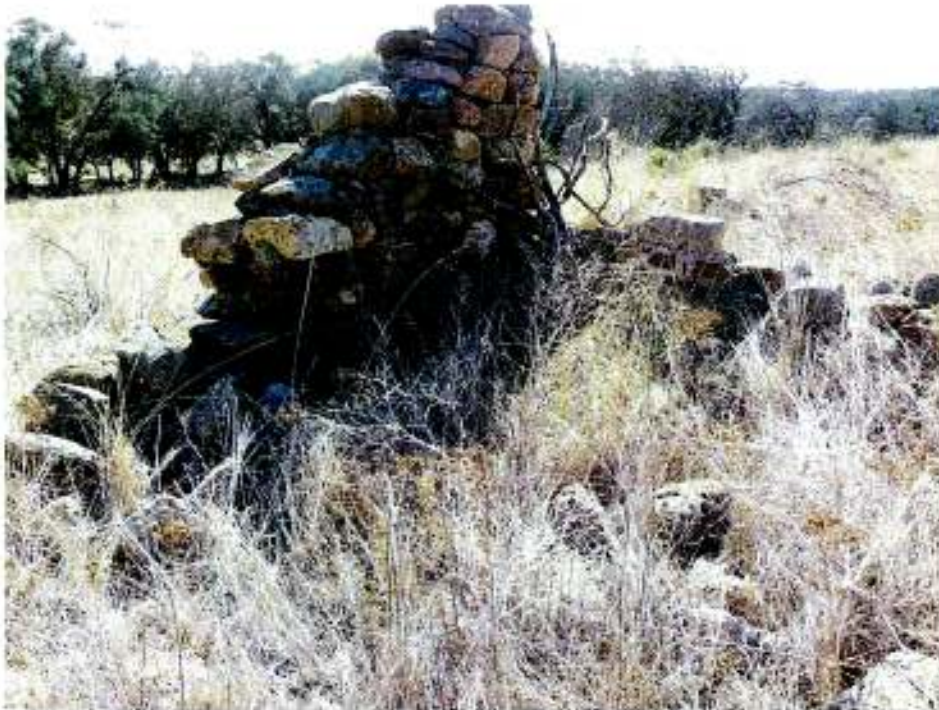
*P06358 Stone dwelling (ruin), Howatharra* View looking northeast showing the 'interior' of the north wall remains. L Gray 15 April 2010.

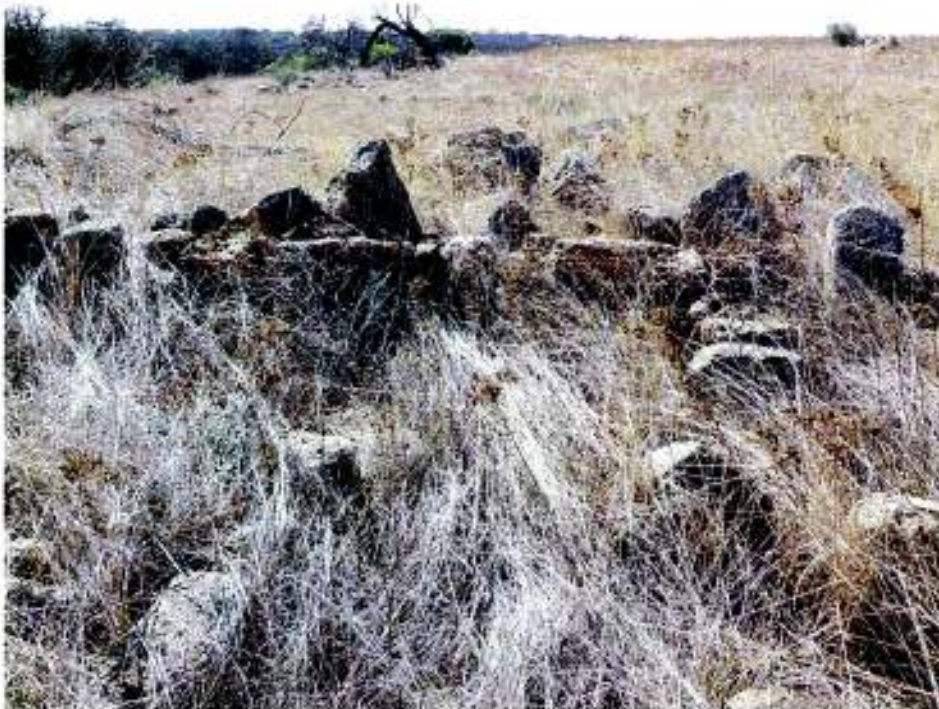
*P06358 Stone dwelling (ruin), Howatharra* View looking east showing the remains of the walls at the southeast corner. L Gray 15 April 2010.
