# FOR ENTRY IN THE REGISTER OF HERITAGE PLACES

1.	DATA BASE No.	P13670						
2.	NAME	Lime Kilns, Howatha	nra					
3.	LOCATION	adjacent Oakajee Ri	ver, Howatharra					
4.	DESCRIPTION OF PLACE INCLUDED IN THIS ENTRY (leave for Land Information Officer to fill in )							
5.	LOCAL GOVERNME	ENT AREA	Shire of Chapman Valley					
6.	OWNER (leave	for Land Information	Officer to fill in )					
7.	Register of Herita     National Trust Cla     Town Planning Sa     Municipal Invento     Register of the National Trust	age Places: assification: cheme: ory:						
8.	CONSERVATION ORDER							
9.	HERITAGE AGREE	MENT						
40

Lime Kilns, Howatharra, the remains of four purpose built vernacular lime kiln elements, has cultural heritage significance for the following reasons:

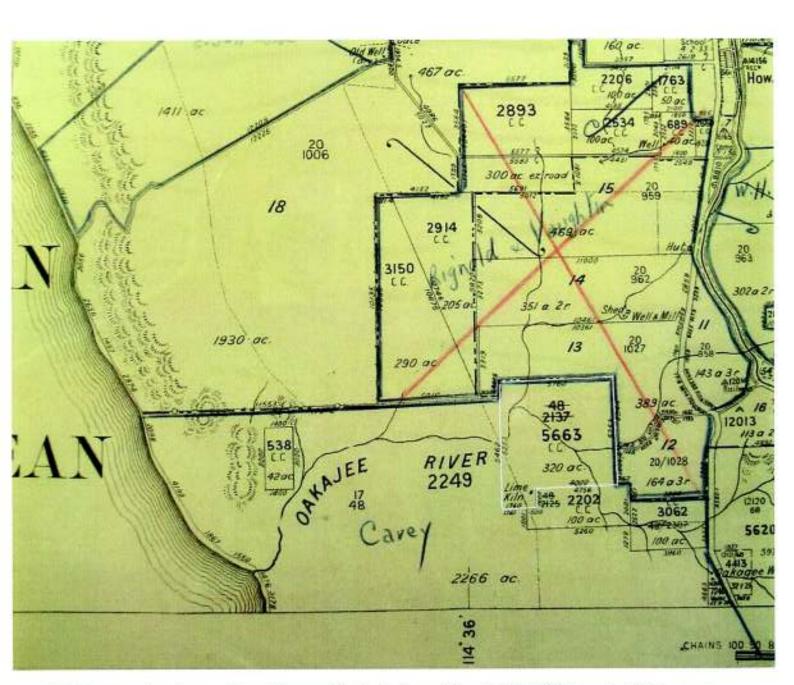
1926 map showing a lime kiln on Victoria Location 5663. WA Lands & Survey, Bonnes 40 cadastral maps, CN77 157A.

the area does not show the kilns but a lime kiln is marked on a 1926 Lands & Survey plan. 13

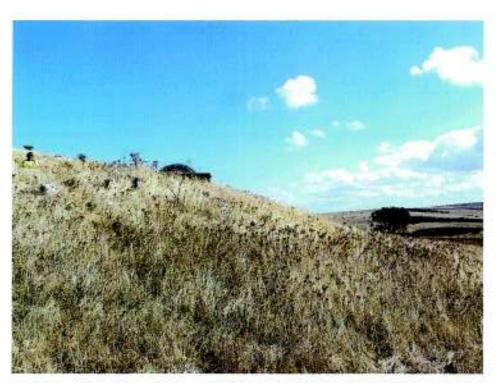
P13670 Lime Kilns, Howatharra Kiln 1: view approaching from the south. L Gray 15 April 2010

Kiln 1 (hillside) is circular with a diameter of approximately 2 metres, situated predominantly below ground. The external lining of the circular form is curved steel plate, and the interior is lined with bricks and stone. The bricks, mostly part bricks are laid in headers around most of the perimeter above ground level, with random laterite stone, and limestone insitu rock beneath. There is random laterite stone above ground level on part of the north and east sides

of the perimeter. The kiln is in a ruinous state filled with debris and the top of the wall, above ground level is damaged and deteriorated. The steel plate is severely rusted, particularly where it has been below ground, and the brick and stone have fallen away on the north and east sides predominantly. A slab of remnant concrete is located adjacent to the kiln on the north side. It is likely that Kiln 1 is the element that has been referred to as an 'Historic well'. However, the evidence indicates kiln associations rather than a well.

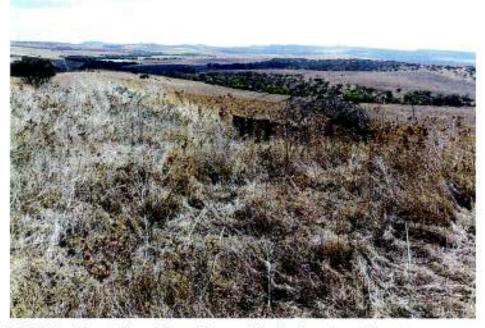
P13670 Lime Kilns, Howatharra Kiln 1: view to northeast. L Gray 15 April 2010

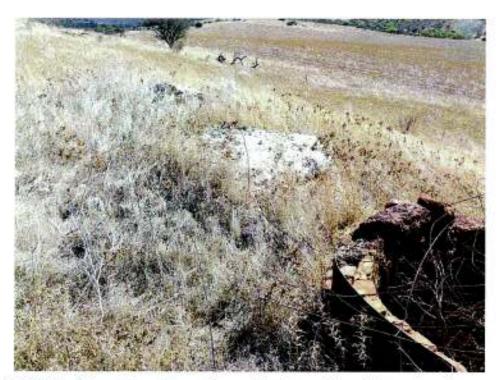
P13670 Lime Kilns, Howatharra Kiln 1: northeast view showing concrete remnant on north side of kiln. L Gray 15 April 2010

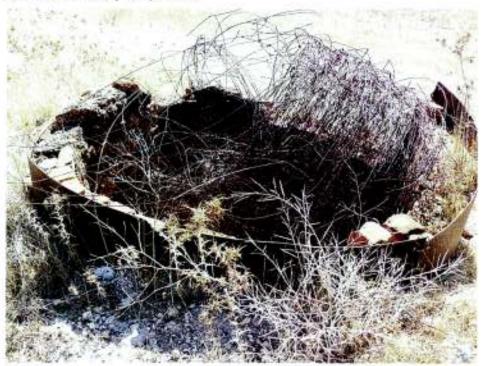
P13670 Lime Kilns, Howatharra Kiln 1: view looking into the kiln from southwest. L Gray 15 April 2010

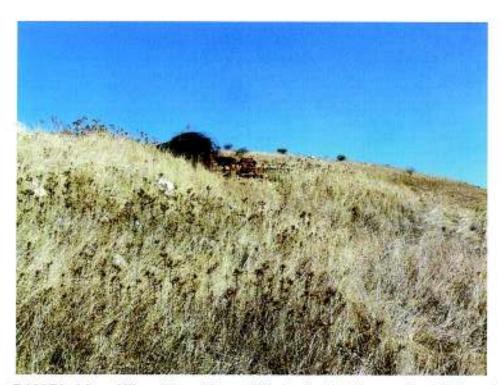
P13670 Lime Kilns, Howatharra Kiln 1: view looking up the hill from the southeast. L Gray 15 April 2010

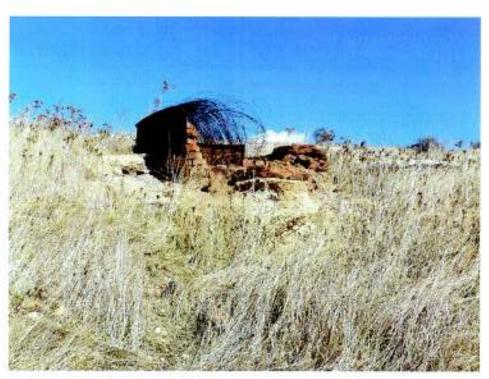
P13670 Lime Kilns, Howatharra Kiln 1: view looking up the hill. L Gray 15 April 2010

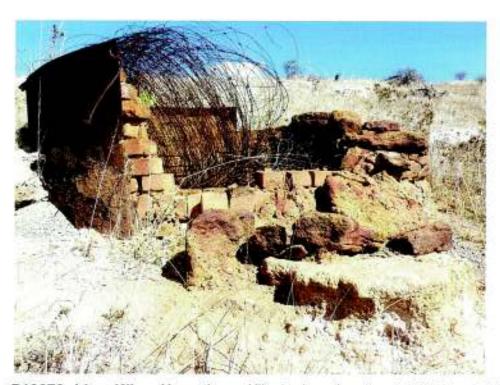
P13670 Lime Kilns, Howatharra Kiln 1: view showing detail of east side. L Gray 15 April 2010

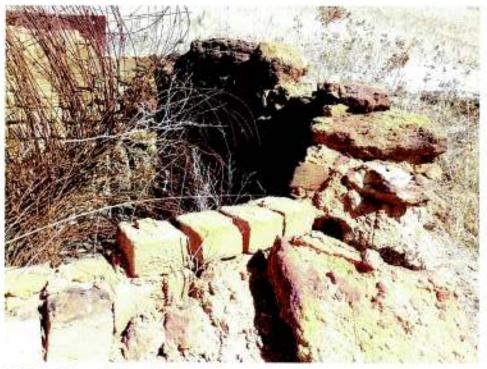
P13670 Lime Kilns, Howatharra Kiln 1: view showing detail of perimeter wall. L Gray 15 April 2010

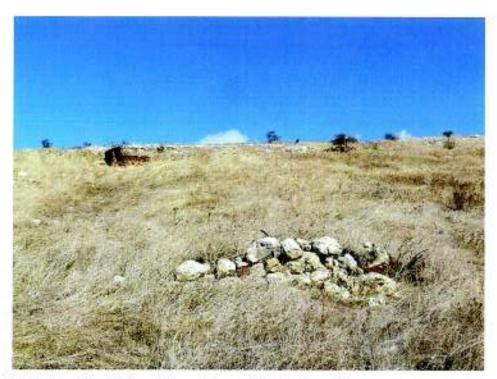
P13670 Lime Kilns, Howatharra Kiln 2: view of remnant stone looking to kiln 1. L Gray 15 April 2010

Kiln 2, located a few metres east down the hill from Kiln 1, is a pile of random limestone stones. It is likely the remains of a vent associated with Kiln 1.

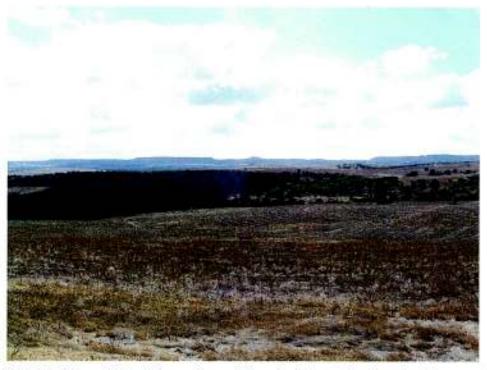
P13670 Lime Kilns, Howatharra Kilns 3, 4 (centre): view looking east from Kiln 1. L Gray 15 April 2010

Kilns 3 and 4 are located in close proximity to each other, central within a former paddock that is now a contoured tree plantation, between the hillside (west) where kilns 1 and 2 are located, and the Oakajee River to the east.

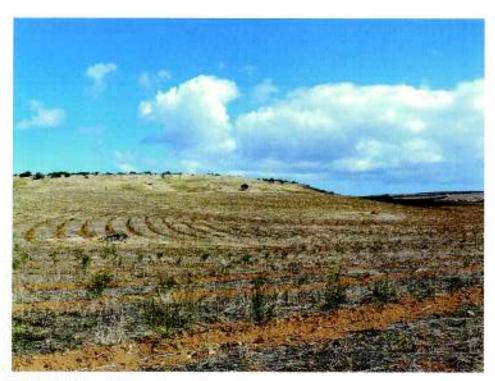
P13670 Lime Kilns, Howatharra View looking west showing kiln 1 (top left) and kiln 4 (mid right). L Gray 15 April 2010

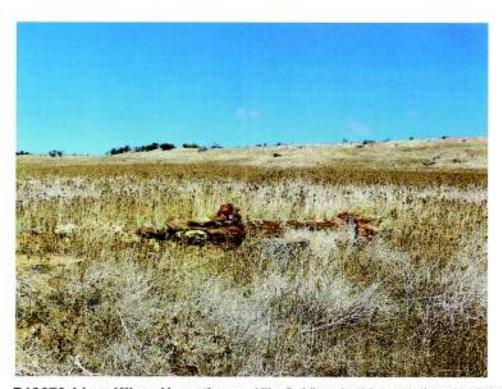
P13670 Lime Kilns, Howatharra Kiln 3: View looking southwest showing kilns 1 (directly behind on the hillside). L Gray 15 April 2010

Kiln 3 (south) evidences the remains of a square or rectangular form laterite stone structure predominantly below ground level, with two and three random stone courses above ground level and a corner detail on the southwest corner, and the east side no longer evident. There is a pile of remnant stone on the southeast corner. The pit surrounded by the stone walls, is infilled with debris.

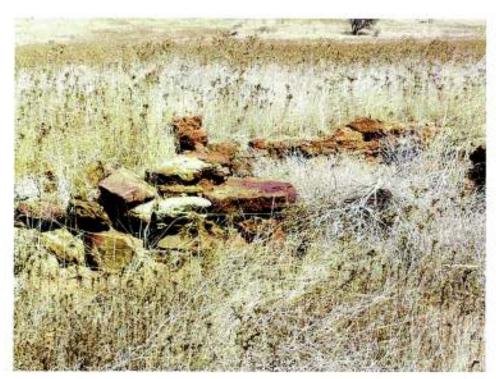
P13670 Lime Kilns, Howatharra Kiln 3: View looking west showing rectangular form.

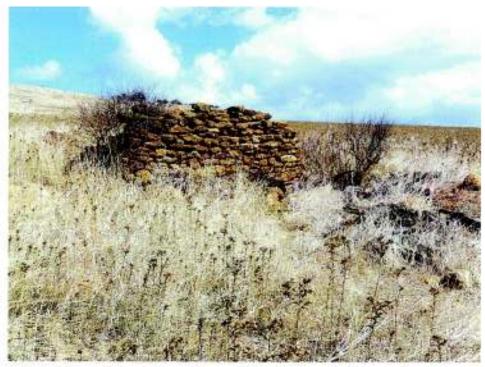
P13670 Lime Kilns, Howatharra Kiln 4: View looking northwest. L Gray 15 April 2010

Kiln 4 is a random laterite stone structure a metre or so high, several metres long with stepped ends, and approximately 0.500 metres of a double and three deep stone wall. The stone wall extends below ground level with an open pit to the front (west), facing up hill, with a pile of remnant stones only a few metres in front. The front wall (west) demonstrates a 'face' finish of the random stone, likely associated with the kiln function and heat element of that function. On the back (east), along the ground level line of the 'wall' there are several openings between the random stones that are likely vents or similar associated with the function of the kiln. The open pit has been filled with debris so the depth is indeterminate.

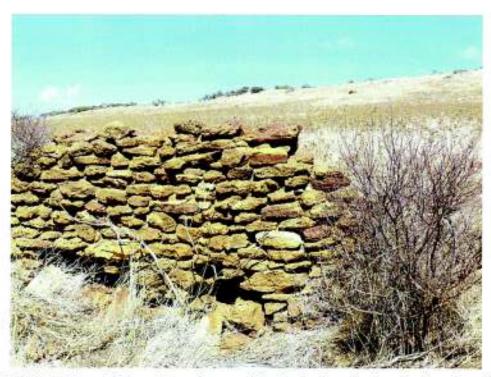
P13670 Lime Kilns, Howatharra Kiln 4: East wall showing low level openings, and kiln 1 on the hillside (looking northwest). L Gray 15 April 2010

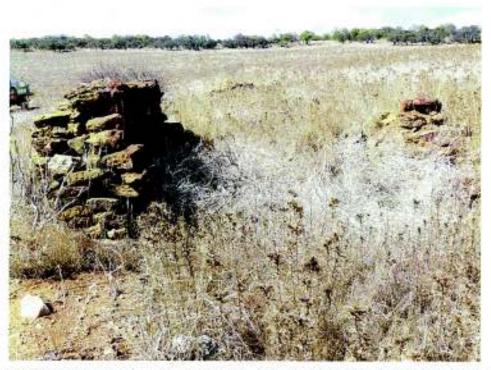
P13670 Lime Kilns, Howatharra Kiln 4: View looking south, showing the remnant stone pile (right), and Kiln 3 behind (centre left). L Gray 15 April 2010

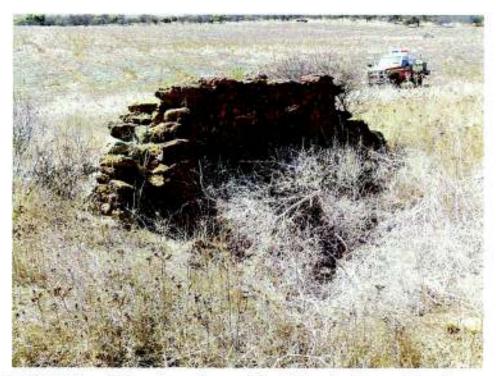
P13670 Lime Kilns, Howatharra Kiln 4: View looking southeast. L Gray 15 April 2010
